**CRITICAL AREAS REPORT AND MITIGATION PLAN**

**MILANO ISSAQUAH APARTMENTS**

**ISSAQUAH, WASHINGTON**

18 September 2020  
(Revised 24 June 2021)

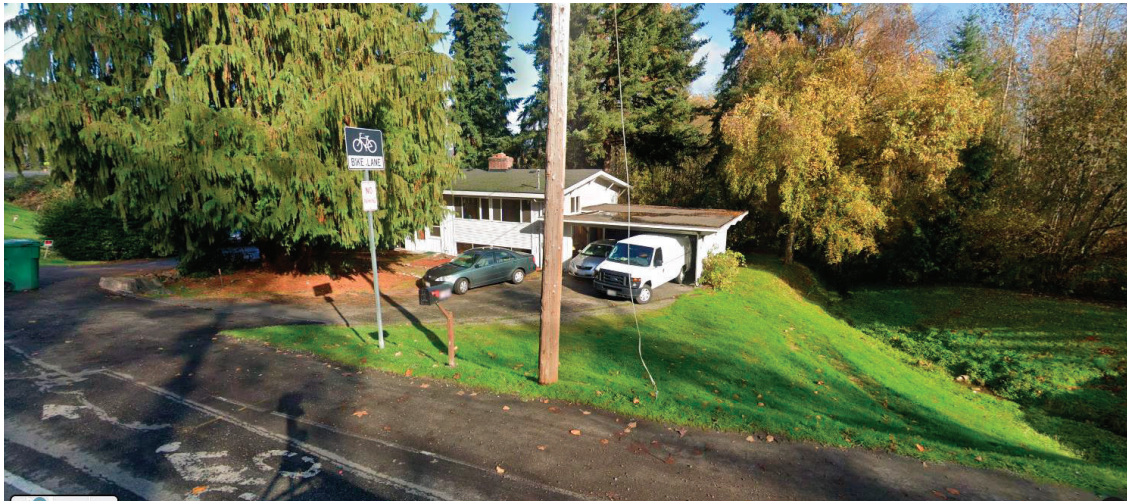
**Photo 1. Existing residence and paved driveway.**

Photo is looking northeast. Schneider Creek located on right side of picture.

The Site is accessed by an existing paved driveway off Newport Way NW that provides access to an existing residence (**Photo 1**). The remainder of the Site is maintained as lawn (**Photo 2**). Schneider Creek is partially located on the southeastern portion of the Site.

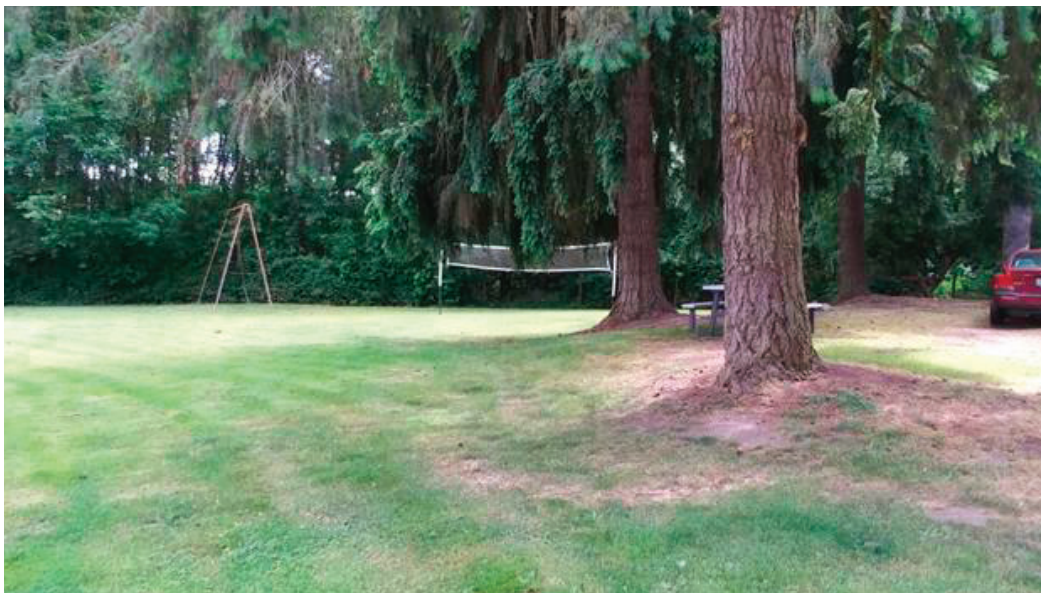
**Photo 2. Lawn areas associated with residence.**

Photo is looking east.

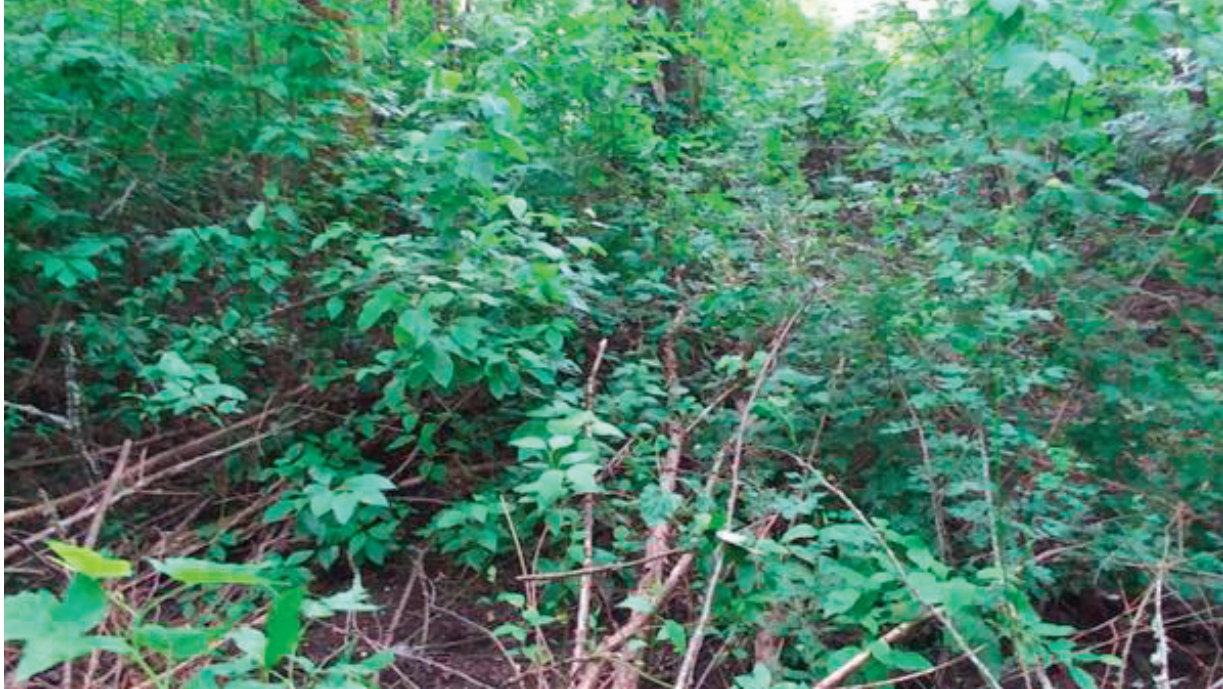
**Photo 3. Wetland B.**

Photo facing east.

Wetland B is an approximately 1,737 SFsf palustrine forested slope wetland (Cowardin *et al.*, 1979) (Brinson, n.d.) associated with seeps that supply Schneider Creek (**Photo 3**). Wetland B is located entirely offsite and is vegetated with black cottonwood (*Populus balsamifera*), Oregon ash (*Fraxinus latifolia*), red alder (*Alnus rubra*), black twinberry (*Lonicera involucrata*), lady fern (*Athyrium filix-femina*), and red-osier dogwood (*Cornus sericea*).

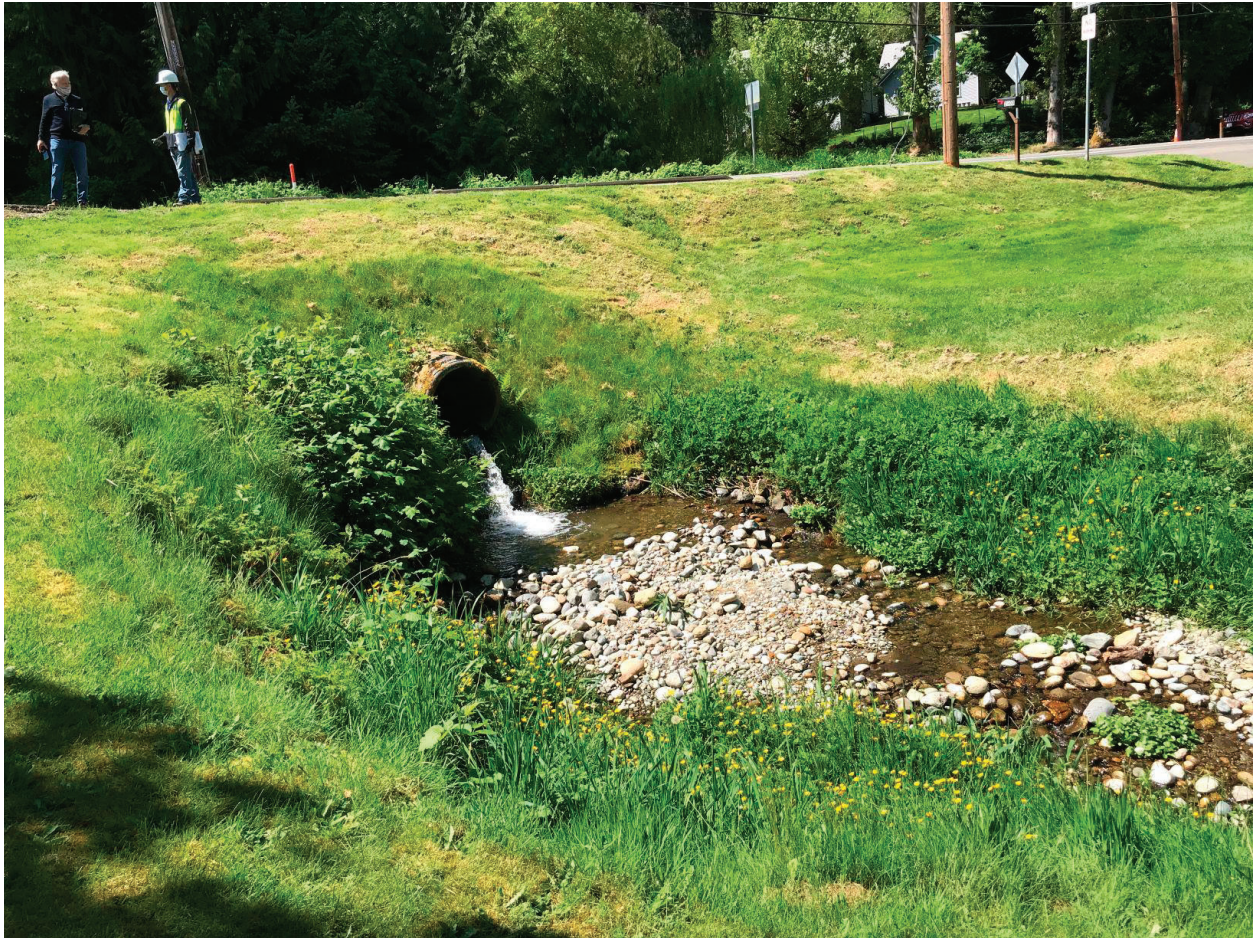
**Photo 4. Perched culvert at Newport Way NW.**

Photo is looking southwest from the shoulder of Newport Way NW.

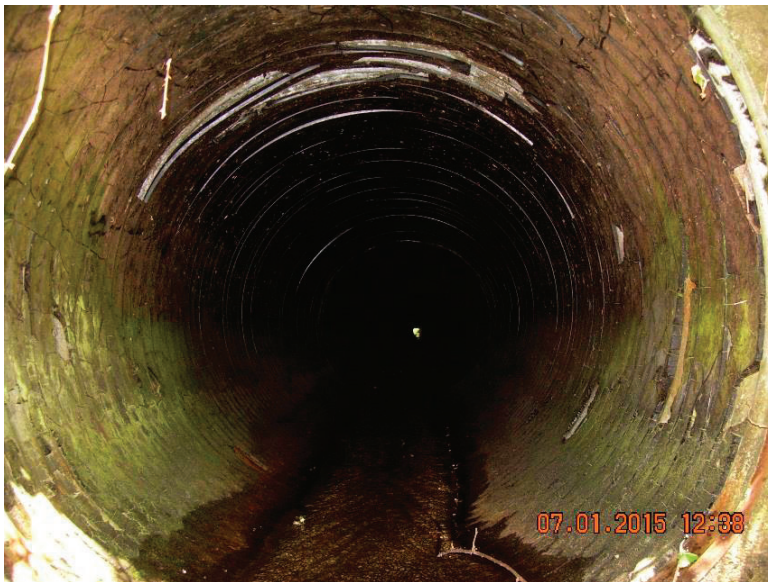
**Photo 5. Schneider Creek in I-90 culvert.**

Photo is looking south from the entrance of the culvert under I-90 and West Lake Sammamish Parkway. There appears to be no blockage in the culvert that might preclude or limit migration of fish.

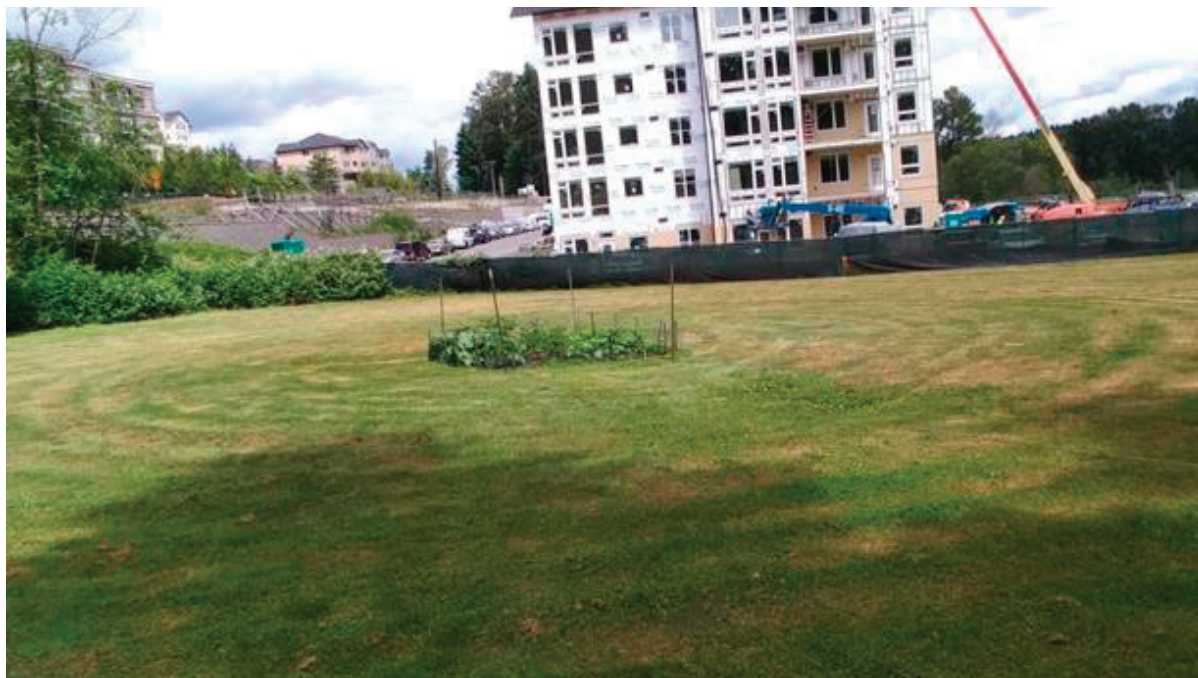
**Photo 6. Wetland B buffer on subject property, existing condition.**

Photo is facing west towards small garden area.

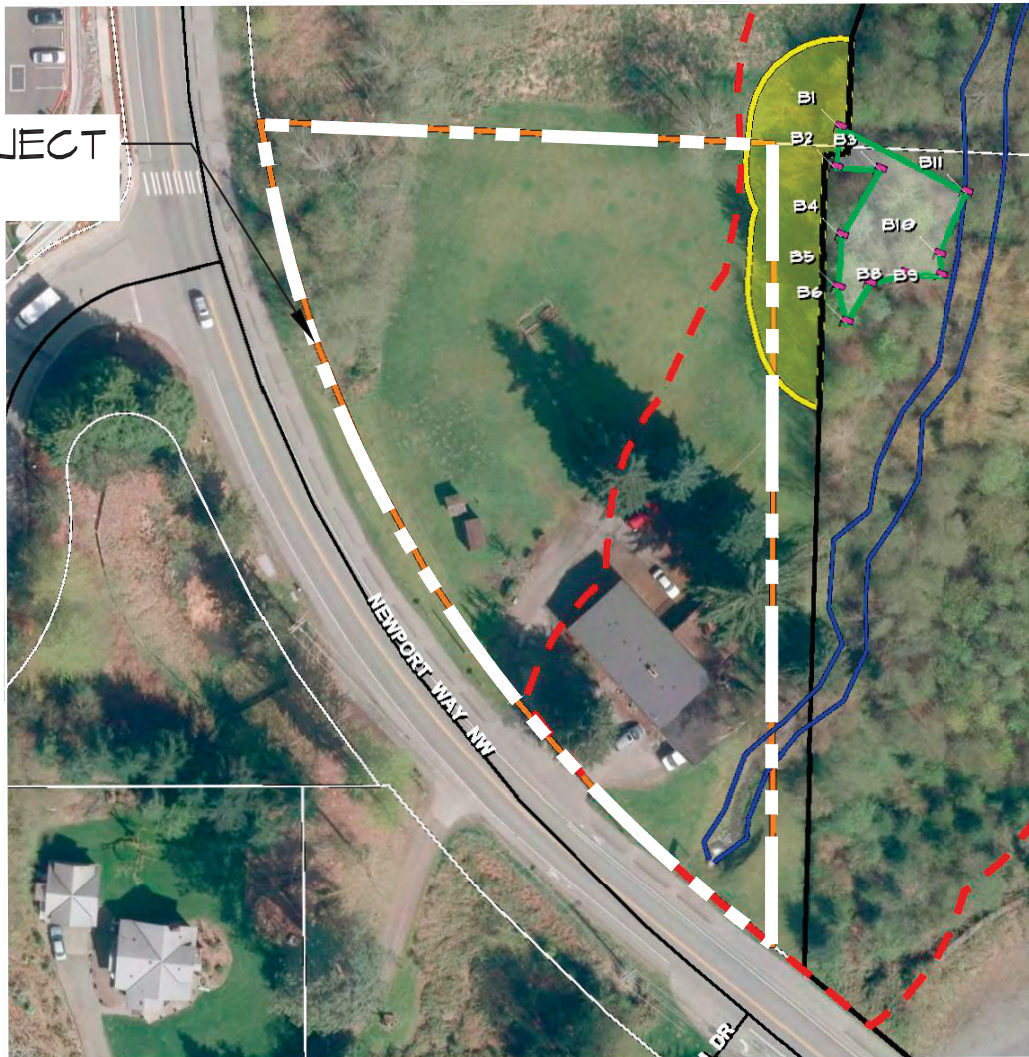
SOURCE: AERIAL IMAGE 2012 FROM EARTH EXPLORER. OHWM AND BUFFER BASED ON SITE SURVEY. WETLAND B BOUNDARY MAPPED USING AN EOS ARROW 100 GPS RECEIVER.
